***A Survey of the Aquatic Invertebrates of Cannock Chase's Forest Streams in Staffordshire, 2023-24, including assessments of water and habitat quality, and future management recommendations.***

<b>Report prepared for:</b>	<b>Cannock Chase National Landscape</b>
<b>CCNL / SCC Contact:</b>	<b>Richard Harris</b>
<b>Survey &amp; report by:</b>	<b>Nick Mott, Staffordshire Wildlife Trust</b>
<b>Species Id and analysis:</b>	<b>Dr Nick Everall, Aquascience Consultancy Ltd.</b>
<b>Date:</b>	<b>February 2025</b>
<b>Title:</b>	<b>'A Survey of the Aquatic Invertebrates of Cannock Chase's Forest Streams in Staffordshire, 2023-24, including assessments of water and habitat quality, and future management recommendations'</b>

Publication data: **Mott, N. (2025). A Survey of the Aquatic Invertebrates of Cannock Chase's Forest Streams in Staffordshire, 2023-24, including assessments of water and habitat quality, and future management recommendations. Staffordshire Wildlife Trust. Report to Cannock Chase National Landscape.**

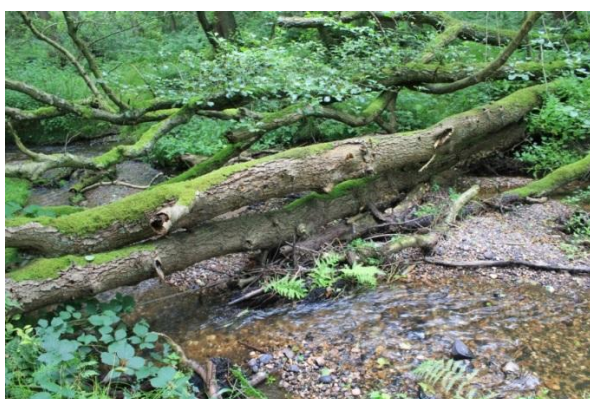
*The middle reaches of the Stony Brook*

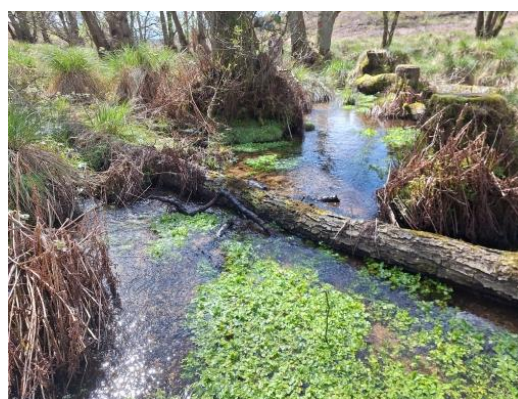
*The upper reaches of the Sher Brook*
